**CNR International**

**MURCHISON DECOMMISSIONING  
COMPARATIVE ASSESSMENT REPORT**

**MURDECOM-CNR-PM-REP-00225**

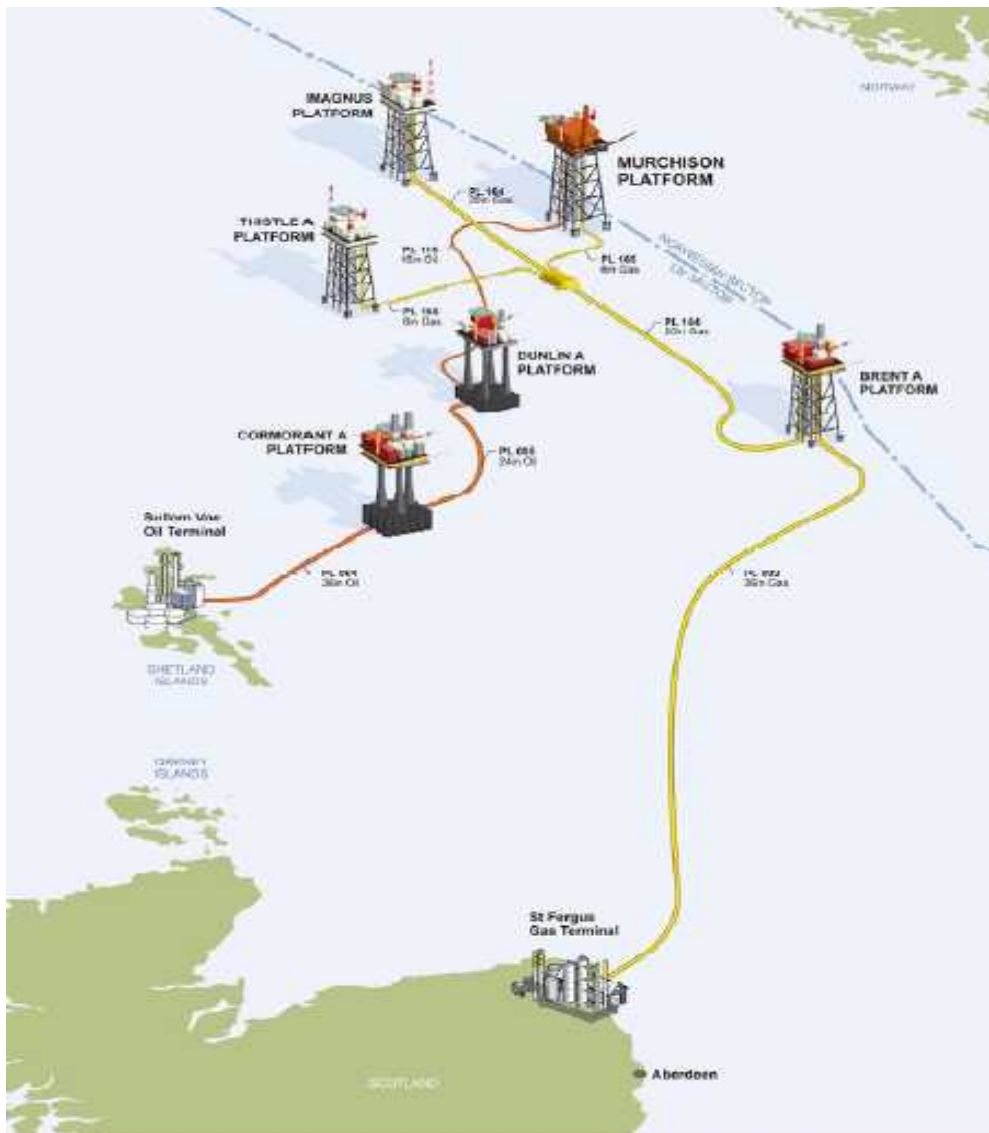
Figure 2: Murchison Field Layout

Murchison is also linked into the Northern Leg Gas Pipeline (NLGP) operated by BP via a 2.6km 6" gas import/export line and an NLGP control umbilical.

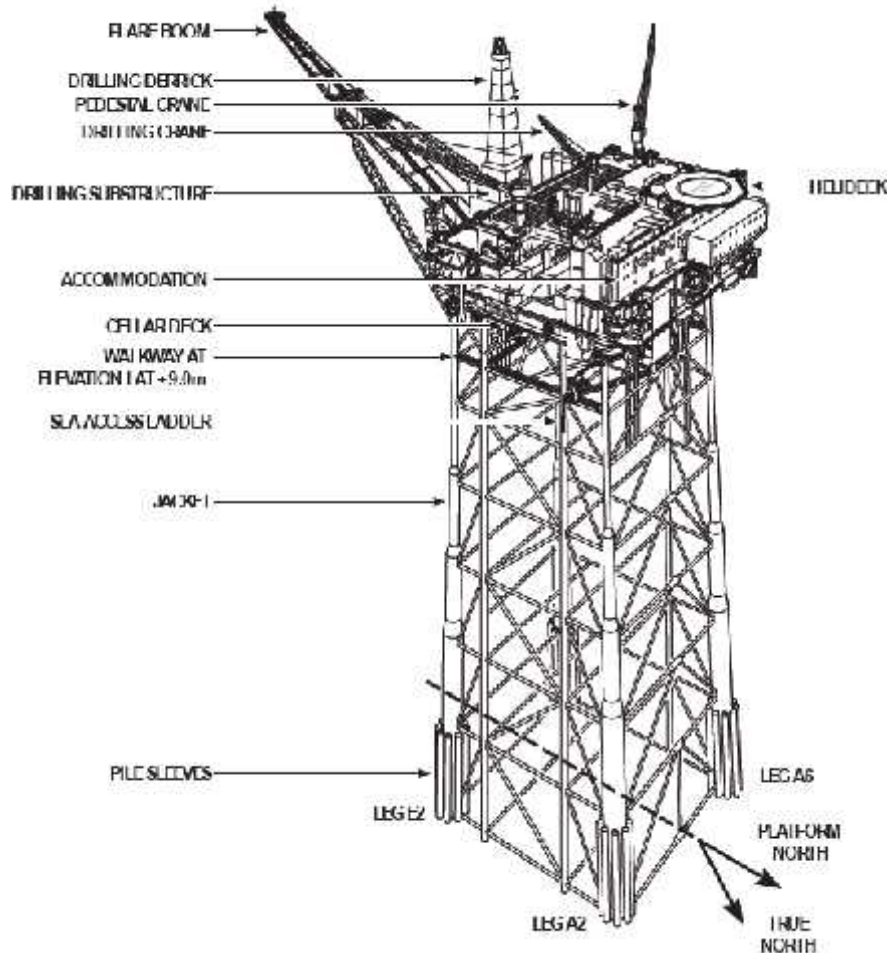
**Figure 3: Murchison Platform Components**

The jacket is an eight leg structure of welded steel construction and measuring 75m by 75m at the base and 52.8m by 62.5m at the top. The overall height of the jacket is 188m.

The jacket foundations consist of 32 piles in groups of 8 around the four corner legs of the jacket. Each pile is 82" in diameter and 80m in length and was designed to be driven some 50m into the seabed. Actual penetrations varied from 40m to 50m.

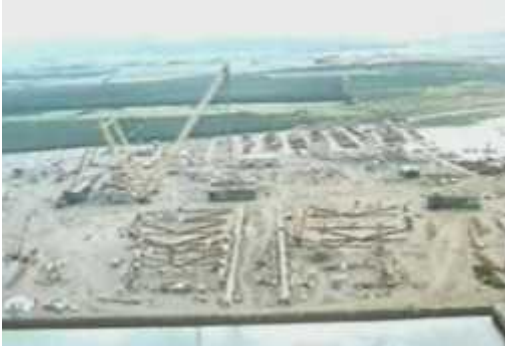
**Figure 5: Layout of Jacket in Yard**

The individual frames of the jacket were assembled horizontally at ground level. The inner two jacket frames were strengthened to provide the launch trusses that take the whole jacket load during loadout of the jacket over the quay edge onto the cargo barge and the launch of the jacket when at the offshore location.

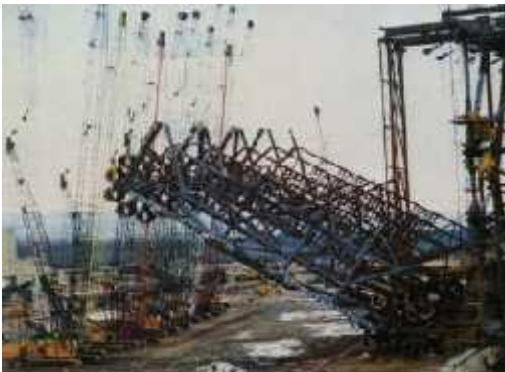
**Figure 6: Roll up of Jacket Outer Frame**

As each frame was completed it was rolled up into the vertical using a spread of synchronised crawler cranes. The largest frame to be rolled up into the vertical weighed over 3,000 tonnes.

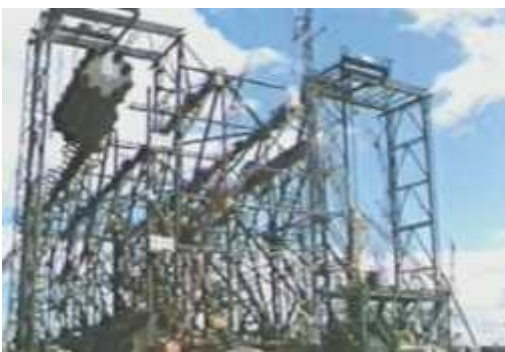
**Figure 7: Installation of the Bottles Legs**

The bottle leg assemblies comprising the main jacket lower leg, pile sleeves, mud mat and connecting shear plates were assembled in Japan and shipped to Ardersier. Each bottle assembly weighed approximately 3,000 tonnes. It was originally planned to lift the bottles into position using a special built crawler crane.

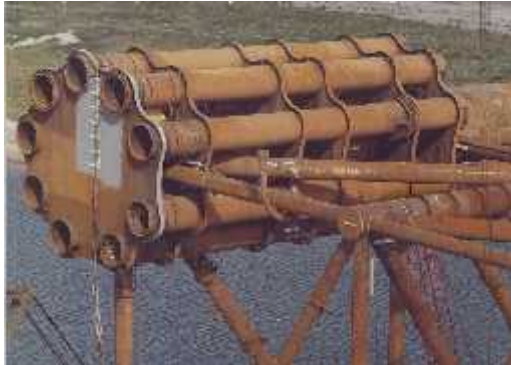
**Figure 8: The Bottle Leg Assembly**

The bottle leg assembly is shown here in its final position after fitting out. The pile sleeves are 2376mm diameter.

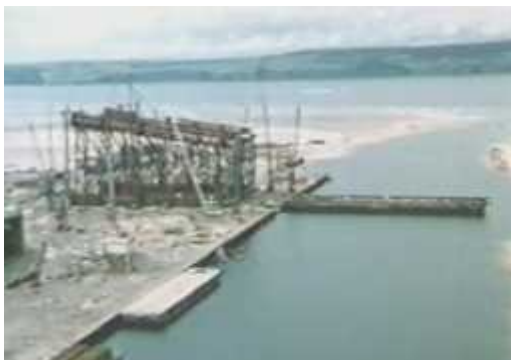
**Figure 9: Jacket Prepared for Loadout**

Figure 9 shows the Murchison jacket after fabrication completed being prepared for loadout onto a sea going cargo barge. Before loadout temporary buoyancy tubes were located in the jacket pile sleeves and the ballast control system installed and commissioned.

The barge was grounded on a purpose built foundation pad in order to transfer the jacket load during loadout.

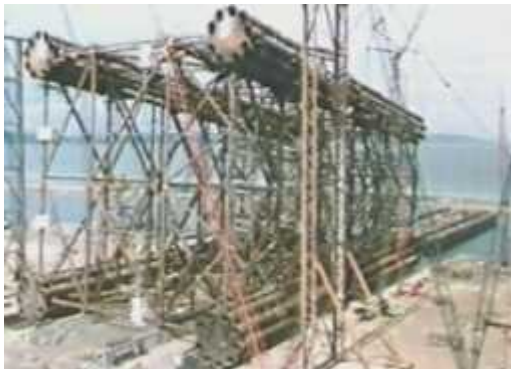
**Figure 10: Loadout of the Murchison Jacket**

Figure 10 shows the Murchison jacket prior to loadout. The jacket was loaded out using purpose design launch trusses integral with the jacket framing. The launch trusses were fitted with timber runners.

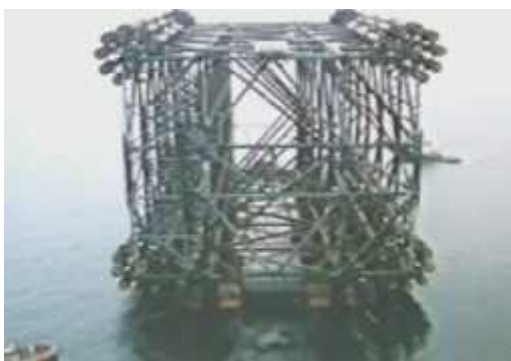
**Figure 11: Jacket Being Towed to Site**

After loadout onto the cargo barge the jacket was towed to the Murchison Platform site.

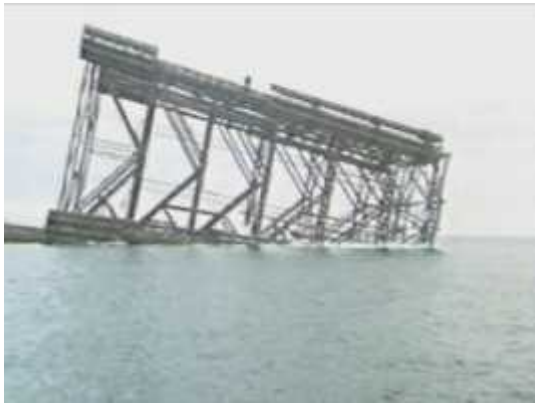
**Figure 12: Jacket Launch**

On arrival at the Murchison location, the jacket was launched, upended using a system of ballast control lines to execute a controlled flooding of the jacket legs. Once confirmed in its correct position, the final ballasting was undertaken to found the jacket on the seabed.

The mud mats provided temporary foundation for the jacket before the main piles were driven. In its unpiled condition the jacket was capable of withstanding a wave of 10.5m without uplift in a corner leg.<sup>9</sup>

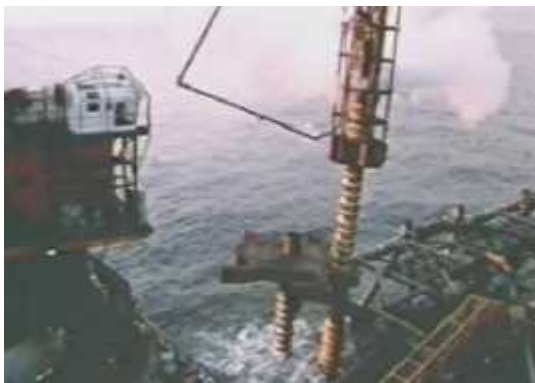
**Figure 13: Jacket Piling**

The temporary buoyancy tanks were removed from the pile sleeves before the piles were installed. Each of the 32 piles was 82 inch diameter and 80m long and driven, using a steam hammer and pile followers, to a design penetration of 50m beneath the seabed. The actual penetrations achieved varied from 40m to 50m.

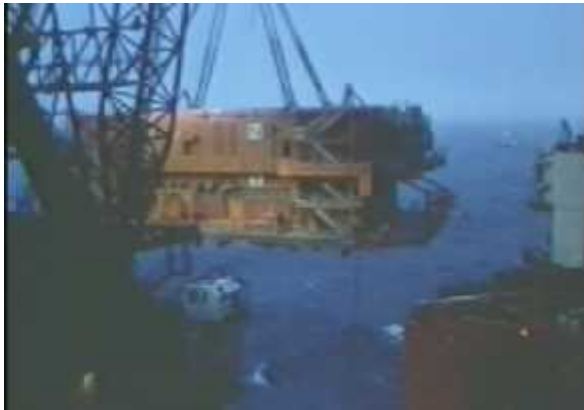
**Figure 14: Installation of Topside Modules**

On arrival by barge to the Murchison platform, each module was rigged up, lifted clear of the barge and set onto the module support frame (MSF).

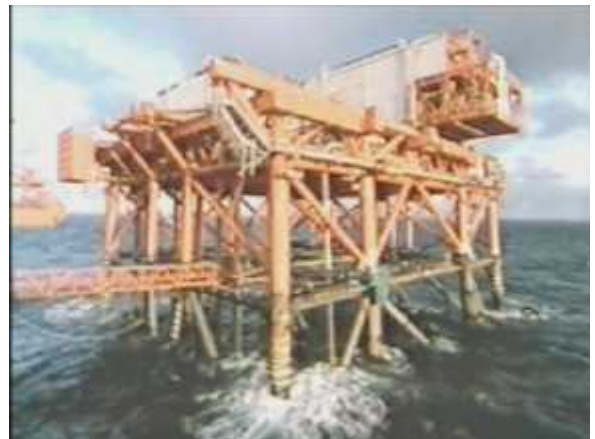
**Figure 15: First Topside Module Installed**

Figure 15 shows the first module to be set down onto the MSF.

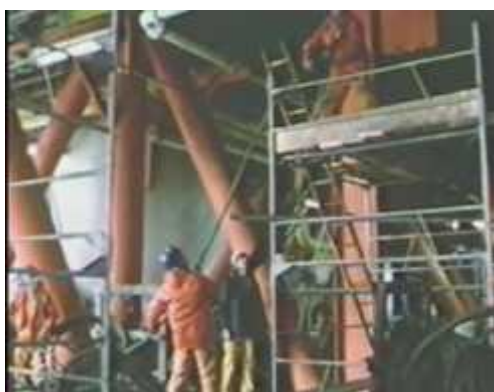
**Figure 17: Hook Up and Commissioning of Modules**

After installing all of the modules, an accommodation vessel was moored alongside the Murchison platform to support the hook up and commissioning (HUC) teams in a 34-week programme.

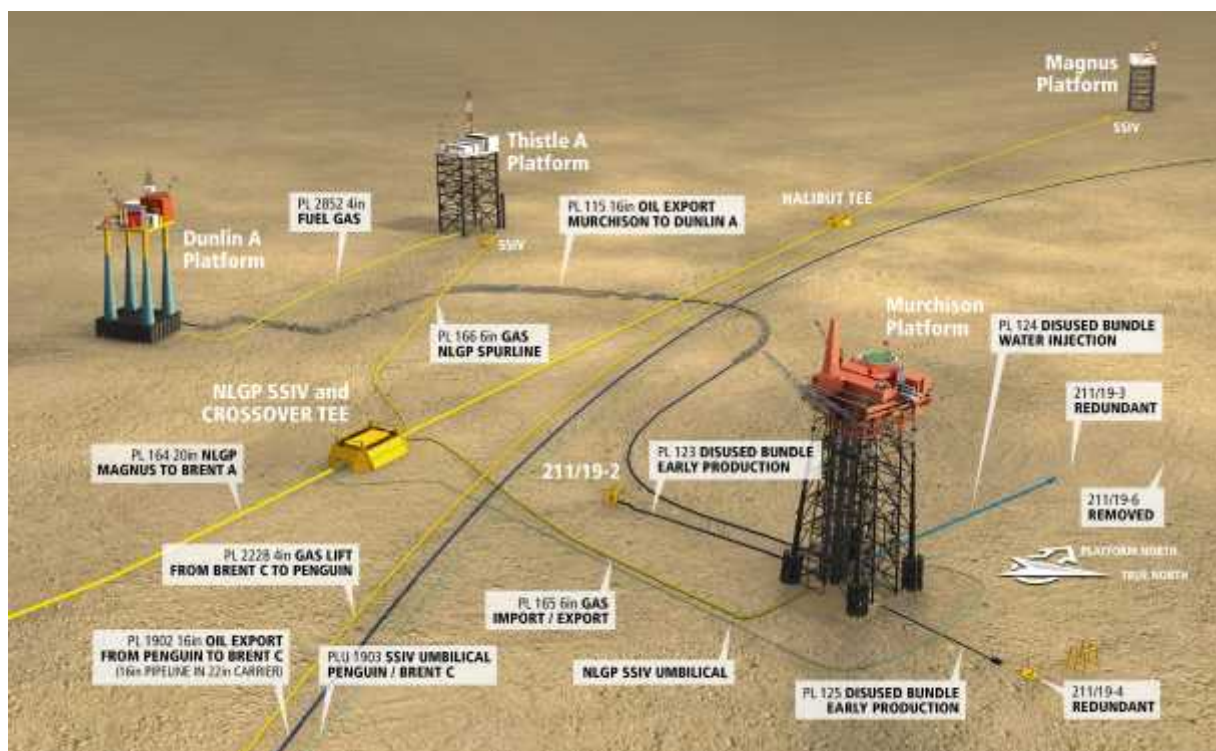
**Figure 18: Murchison Subsea Infrastructure**

The Murchison Platform ties into a pipeline infrastructure as shown below in three principal configurations:

- The pipeline bundles PL123, PL124 and PL125 which formed part of the early production facilities.
- The Oil Export Pipeline (OEL) PL115 which exports produced oil to Dunlin and then onto Sullom Voe terminal via the Cormorant Platform.
- The Murchison Platform imports gas from the BP-operated NLGP network via PL165 and associated control umbilical. These lines will be decommissioned at a later date as part of the NLGP system and are therefore not part of the Murchison Programme.

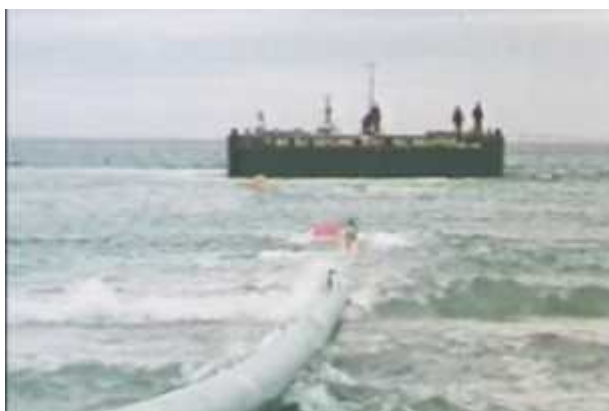
Figure 19: Tow Out of Flowline Bundle

Each of the pipeline bundles was fabricated in a single length at a special onshore yard at Wick.

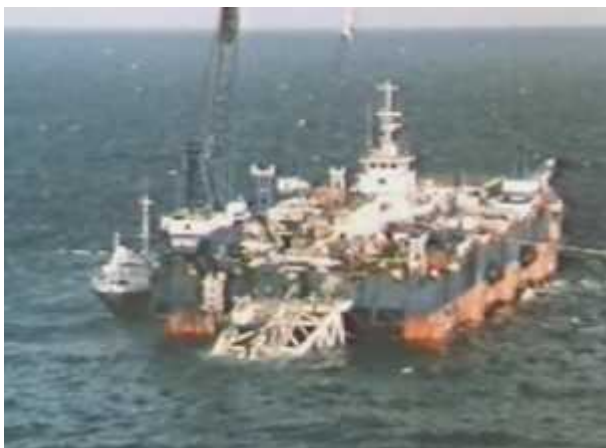
**Figure 20: Laying the 16" OEL to Dunlin**

Figure 20 shows laying the oil export line from the Semac 1 vessel in 1980. The stinger is shown in white, partly submerged.

The coated pipe was shipped out to the Brown and Root lay barge – ‘Semac 1’ – in 12m lengths. The individual lengths were joined and run out over the stinger in a lazy-S configuration to lie on the seabed.

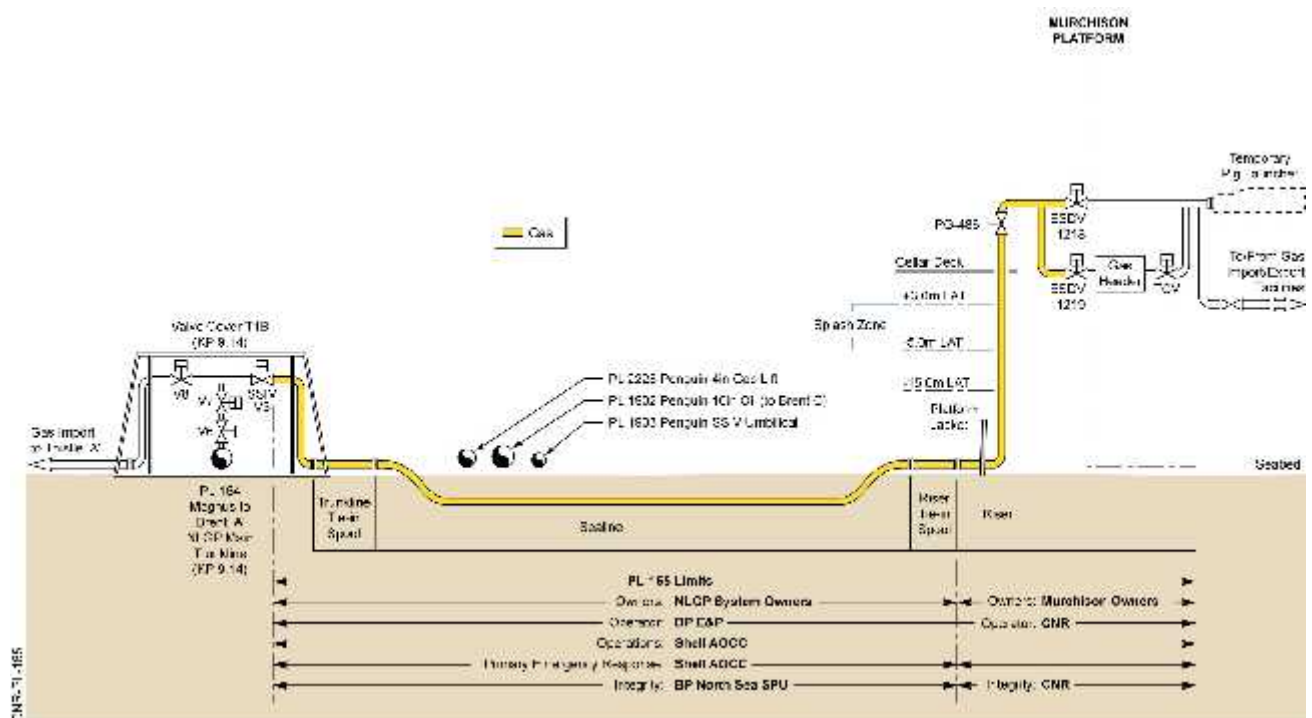
Figure 23: PL165 Schematic

The Murchison gas import riser, shown in Figure 23 below, is connected to the main PL165 at the subsea riser tie-in spool. The riser will have to be disconnected from the main pipeline when Murchison is decommissioned in preparation for the decommissioning of the main PL165 which will be undertaken by the NLGP owners at some future time.

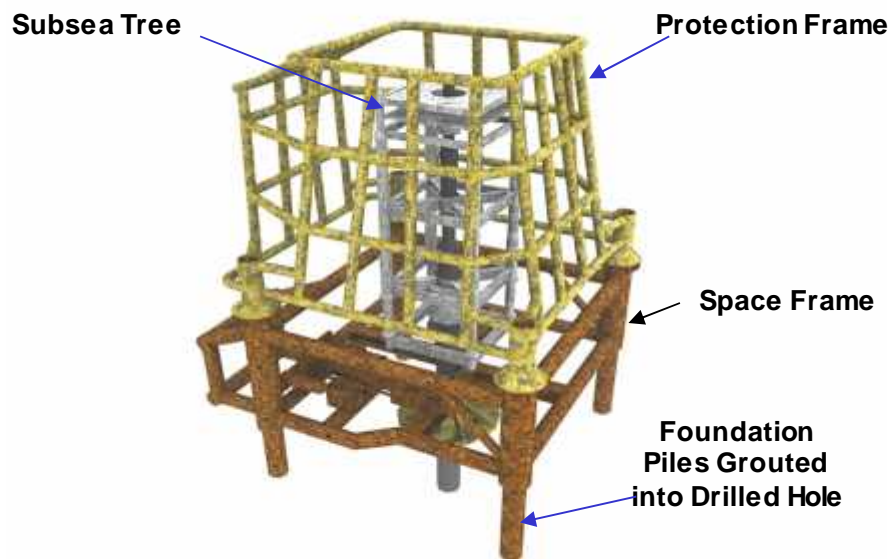
**Figure 24: 211/19-2 Subsea Installation**

A schematic of the wellhead protection structure is shown in Figure 24.

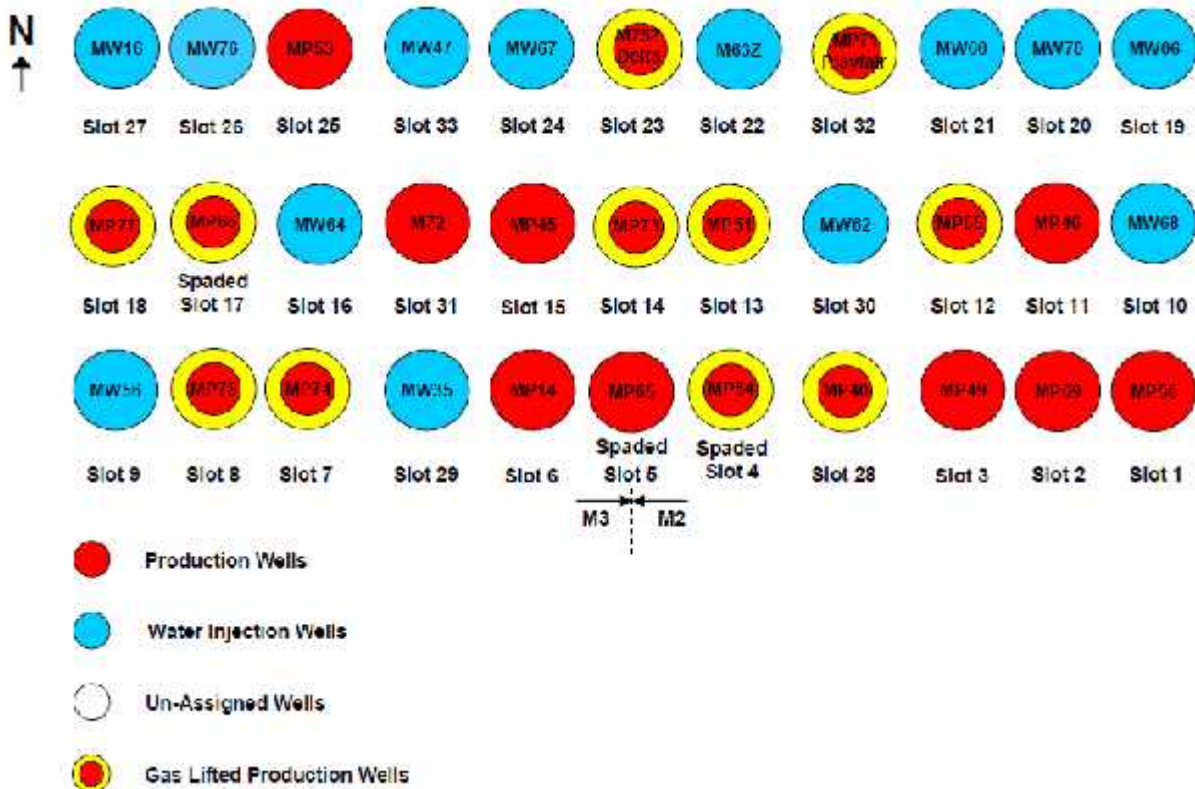
Figure 25: Murchison Well Slot Diagram

Currently, 18 slots are active producers and 13 slots are injectors, with two slots (M16 and M50) which are abandoned due to integrity issues with the wellbores. The layout and designation of wells is shown in Figure 25.

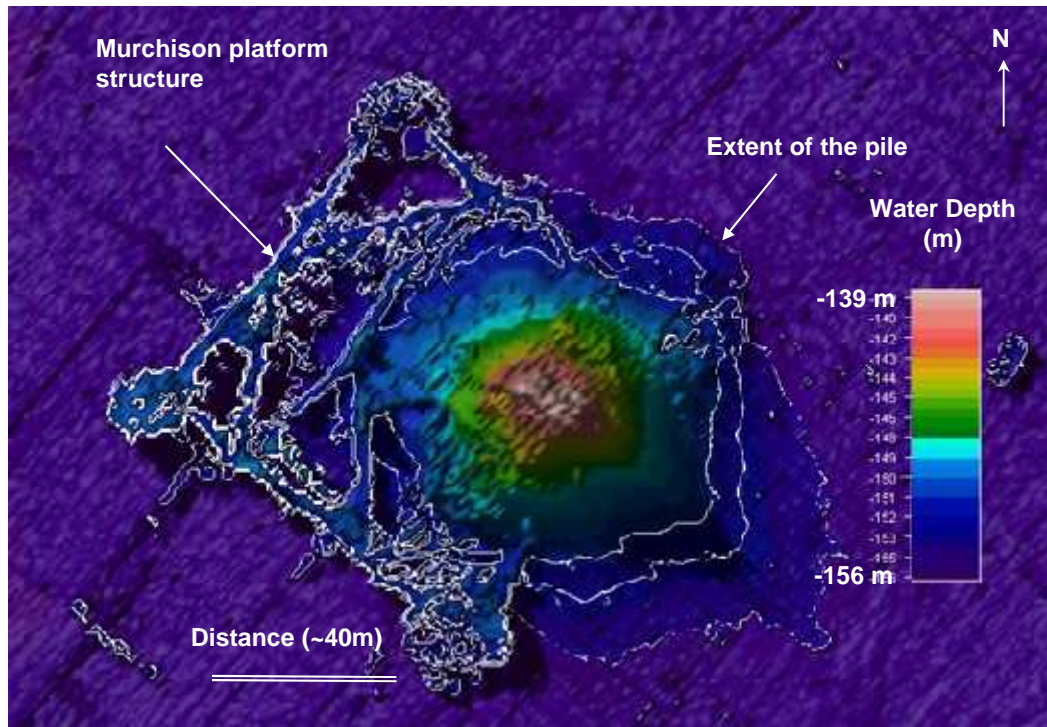
**Figure 27: MBES Survey Data of the Murchison Drill Cuttings Pile**

The footprint area and volume of the Murchison cuttings pile were calculated as 6,840m<sup>2</sup> and 22,545m<sup>3</sup> respectively, shown below.<sup>25</sup>

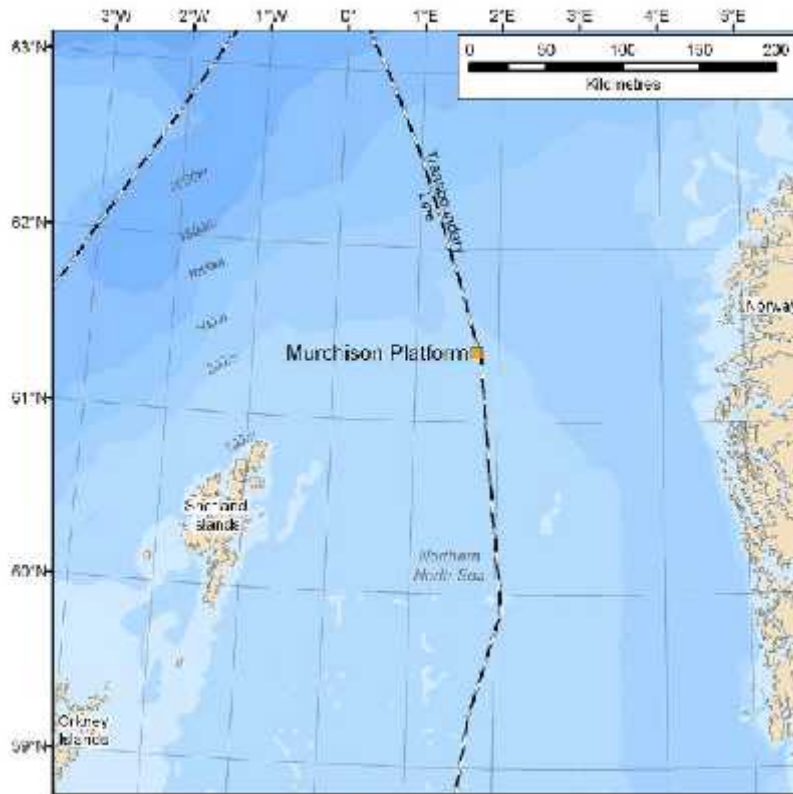
**Figure 30: Bathymetry Map of the Murchison Area**

Water depth at the Murchison field is approximately 156m. The seabed in the vicinity of Murchison is mainly flat with a northwards gentle slope from about 150m to 200m.

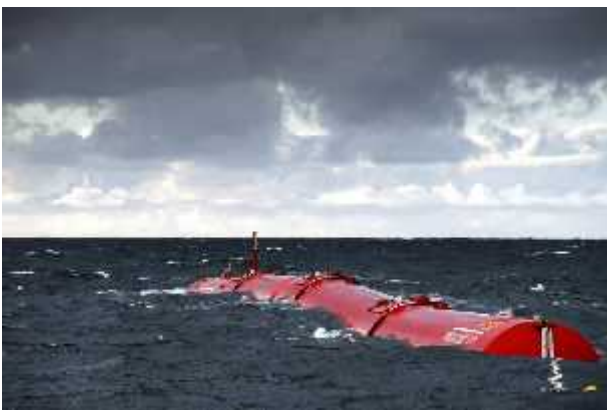
**Figure 33: Pelamis Device Prototype**

The methods of converting wave energy to electrical energy are diverse, but in deep water the devices tend to be floating or tethered to the seabed such as the Pelamis Wave Energy Converter.

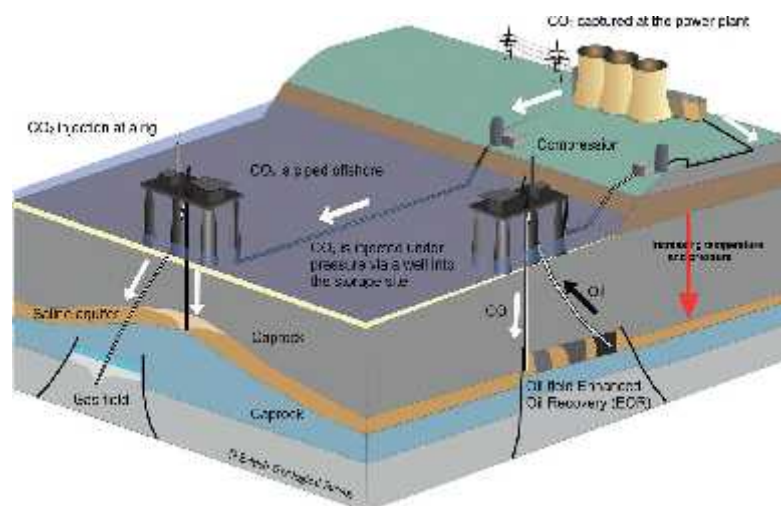
**Figure 34: CCS Schematic**

Figure 34 is a schematic showing elements of a CCS infrastructure in relation to the required geological sub surface structure<sup>40</sup>.

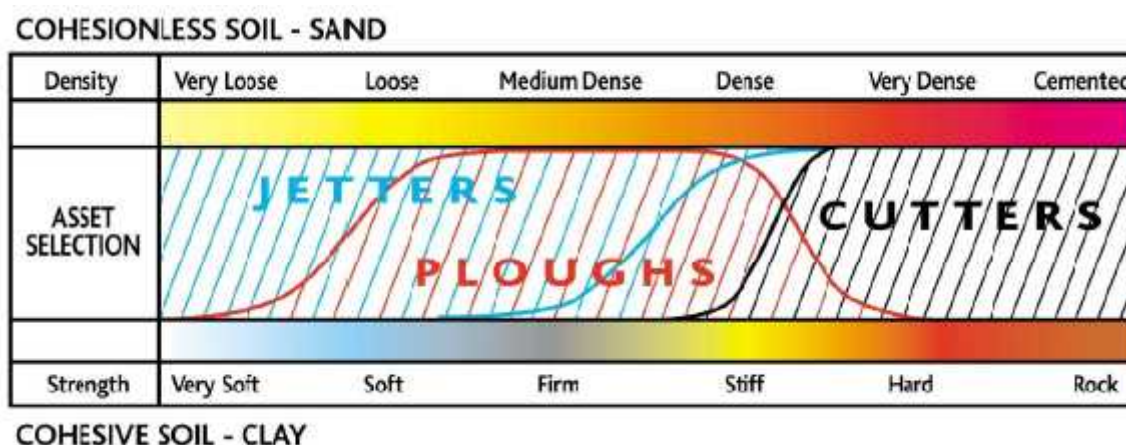
**Figure 35: Trenching Equipment V Soil Type**

For the trench and burial operations, the selection of tool will depend on the soil conditions. For the stiff clays along the pipeline route cutting equipment will probably be the only practicable alternative, as shown in Figure 35.

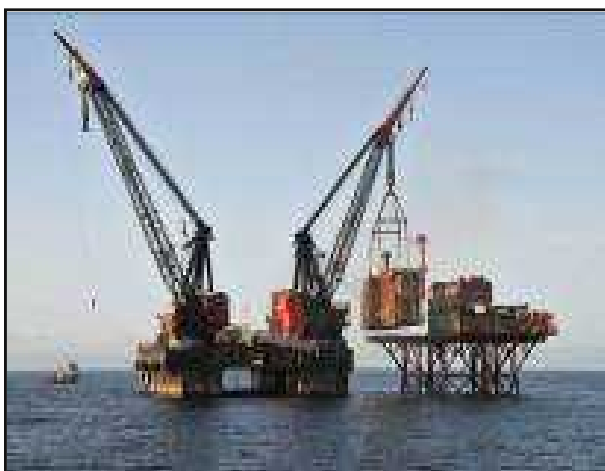
**Figure 36: SSCV Lifts off Topside Module**

After removal individual modules and components will be shipped to shore and unloaded at a licensed reception facility<sup>50</sup>. The reception facility will be nominated by the removal contractor at the appropriate time and will be subject to CNRI approval.

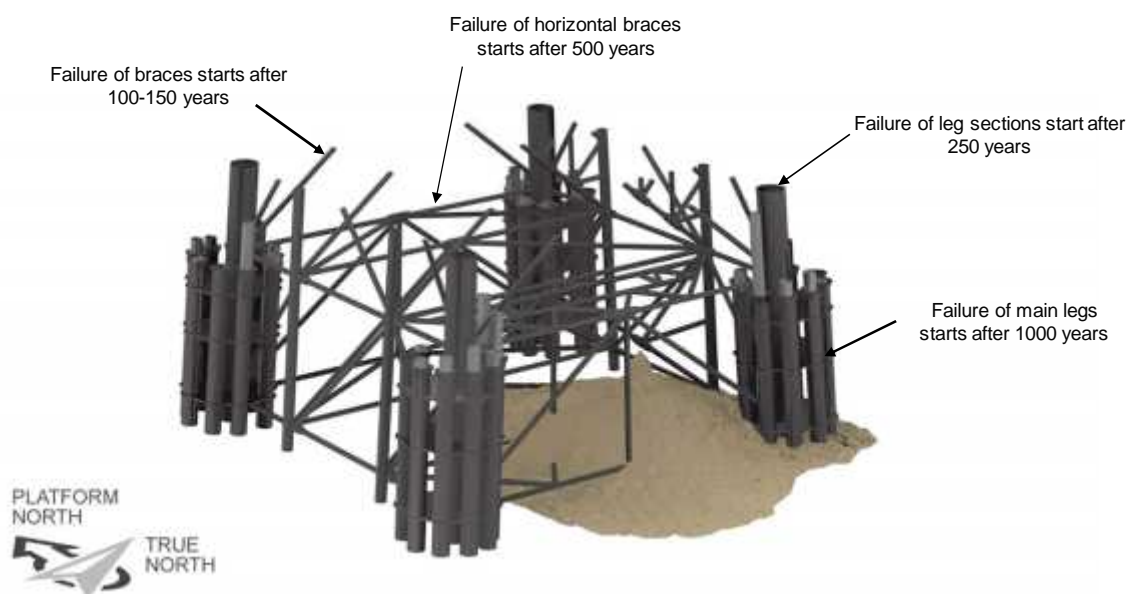
**Figure 40: Predicted Degradation Rate of Footings**

The most important factors which affect the corrosion of metals immersed in unpolluted sea water are dissolved oxygen and temperature. These factors were addressed in a study predicting the life expectancy of the footings left in place, over time.<sup>54</sup>

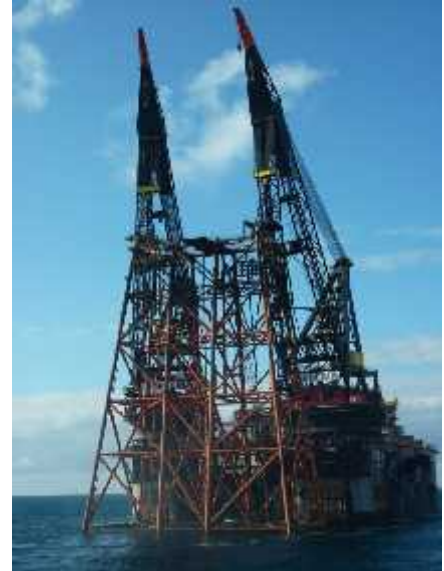
**Figure 41: Jacket Removal Using a Heavy Lift Vessel**

Figure 41 shows a jacket being removed using a semi-submersible dual crane vessel (SSCV). The SSCV with a crane capacity of 14,000te is able to remove the jacket in large sections.

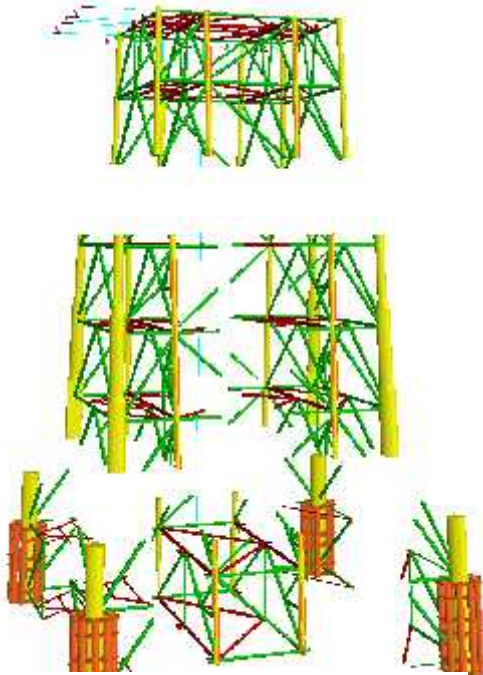
**Figure 42: Jacket Removal in Large Sections**

The larger SSCVs could remove the jacket in sections weighing up to 4,000te, as shown in Figure 42.

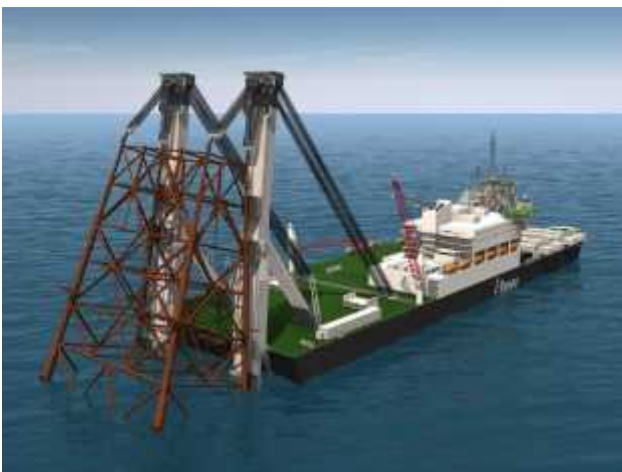
**Figure 43: Jacket Removal Using a Single Lift Vessel**

Figure 43 shows a jacket being removed using the new single lift vessel (SLV) the *Pieter Schelte*, currently under construction. The single lift vessel has a jacket lift system capacity of 25,000te whereas the Murchison jacket has a total lift weight of 26,131te.<sup>63</sup>

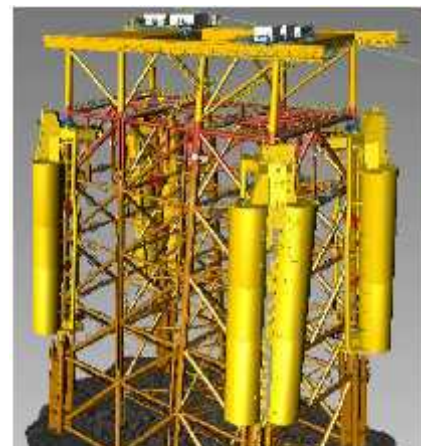
**Figure 44: Refloat of jacket using added buoyancy tanks**

Figure 44<sup>66</sup> illustrates a different removal concept which is based on reusing the buoyancy tank assemblies (BTA's) that were used to refloat the 12,000te Frigg DP2 jacket.

To provide additional buoyancy the four corner jacket legs would have to be made airtight after removing the module support frame, and a new buoyancy control system installed for each leg.

The jacket foundation piles would be cut using internal pile cutting, or excavated beneath mudmats for an external cut should debris prevents access for the internal pile cutting tools.

The point during the operation at which the buoyancy tanks are attached to the jacket and the foundation piles are cut would introduce new temporary hydrodynamic loading conditions for which the jacket has not been designed.

Tow lines would be attached and the jacket towed along a deep-water route to a fjord in Norway, where the jacket would be grounded and dismantled *in situ* using shear leg cranes. A series of tow analysis for both the intact and damaged condition<sup>67</sup> would need to be undertaken to verify the jacket structural integrity would be maintained during the tow.

<sup>67</sup> Intact and damaged condition analysis are standard floating/tow analysis requirements that model the consequence of loss of buoyancy in one of the BTA's or other members providing buoyancy caused by damage or failure.

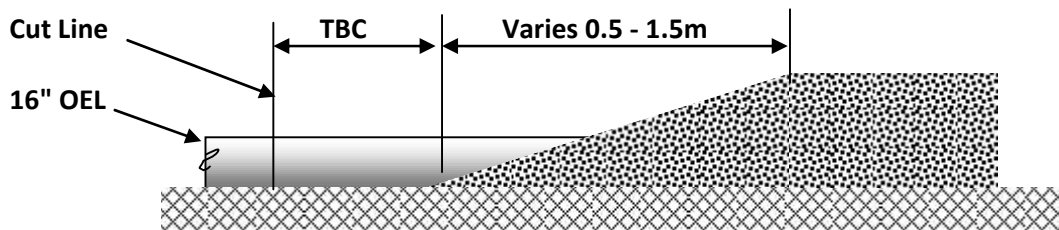
**Figure 45: Location of Cut Lines in PL115**

Each section would be cut using hydraulic shears, diamond wire cutting (DWC), abrasive water jet cutting (AWJC) or chop saws as appropriate. To make the cut, using DWC or AWJC cutters, either the pipeline would have to be lifted off the seabed using a deployed lifting frame with hydraulic operated clamps, or a short trench would have to be excavated to allow the tool access. Cutting excavation trenches in the very stiff Murchison clays is problematic. In 2006 CNRI took 40 hours to excavate a single 5.4m long x 2m wide x 800mm deep trench along PL115.<sup>78 79</sup> Using the hydraulic shears for cutting does not require lifting or excavation. The location of the cut line from the edge of the rock cover is shown in Figure 45 and will be determined to suit the cutting tool selected.

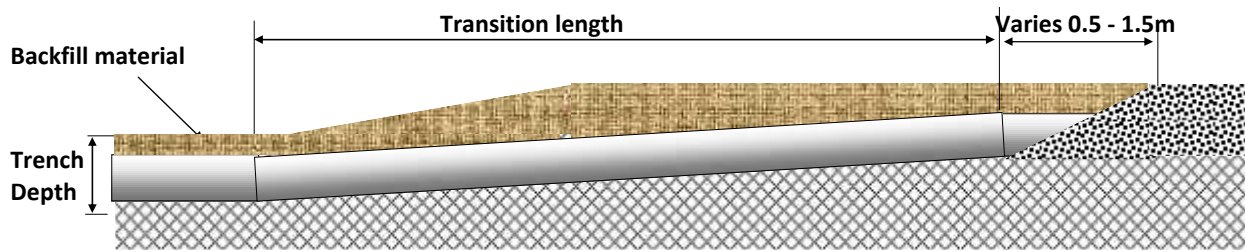
Figure 46: Transition from Rock Placement to Trench<sup>80</sup>

The transition length would be covered by rock placement to match existing profile. It has been estimated that between 6,000 and 12,000<sup>81</sup> tonnes of crushed rock would have to be placed to cover the 17 exposed transition lengths.

<sup>81</sup> Estimate is based on 50m length with average cover 2.2m rock density 2.2kg/m<sup>3</sup> and 17 transition lengths

The area of the seabed directly impacted by the rock placement would be approximately 8,500m by 5m which is equivalent to 0.043km<sup>2</sup>.

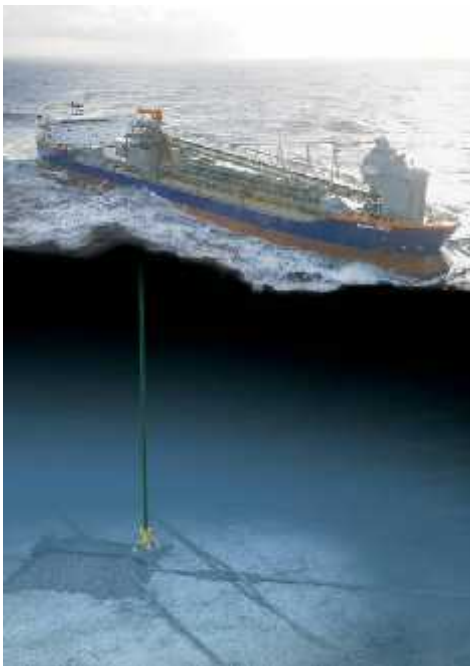
Figure 47: Typical Rock Placement Vessel

Rock placement would use graded crushed rock that matches the existing rock material specification. The graded rock would be placed onto the seabed in a carefully controlled operation using a dedicated rock placement vessel equipped with a dynamically positioned fall pipe.
